Fluid Containment Leaders

Manhole Restoration with Calcium Aluminate Cement

Restoration of Manhole with Calcium Aluminate

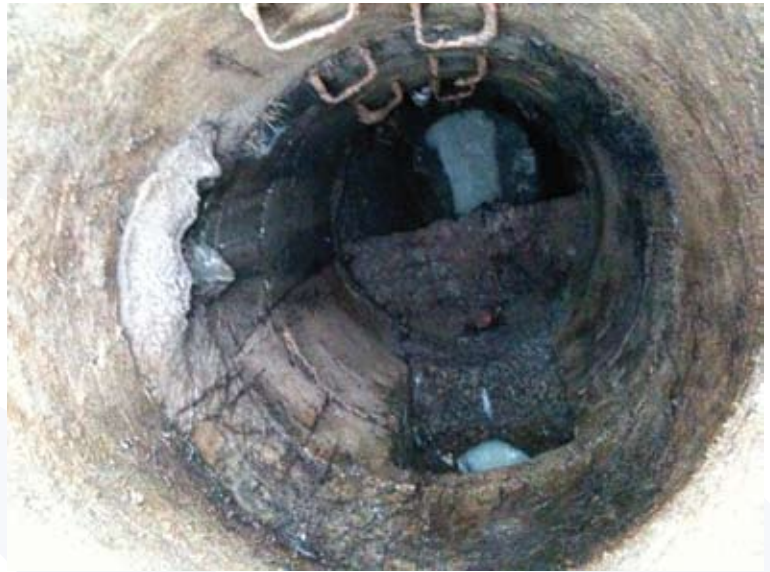
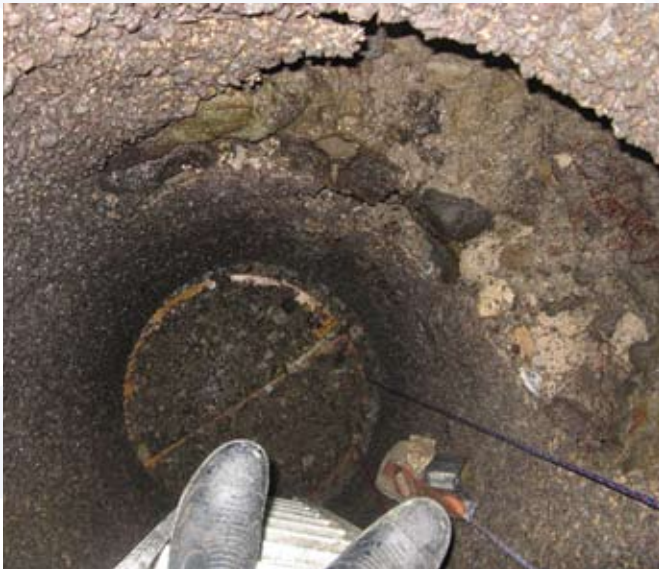
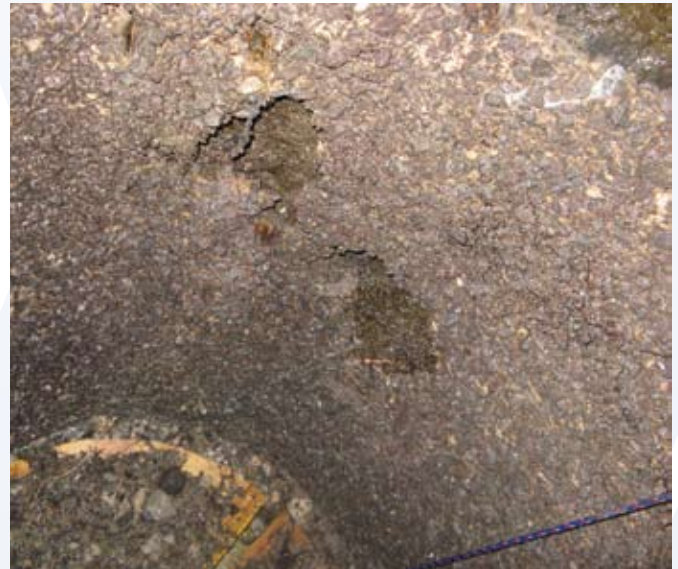
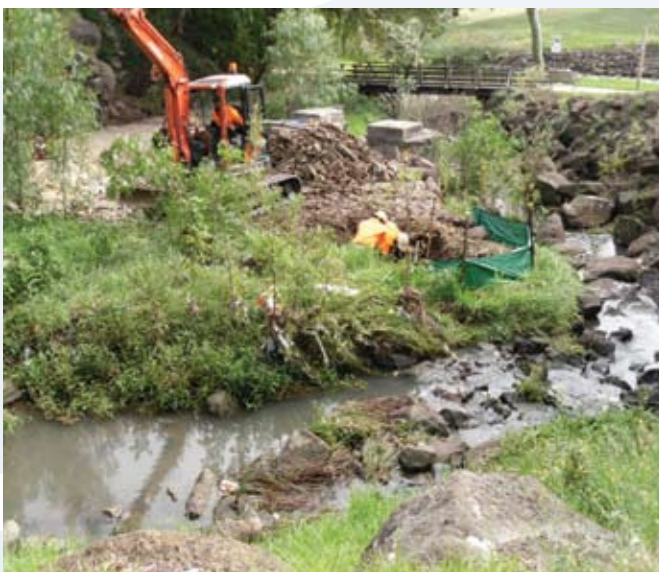
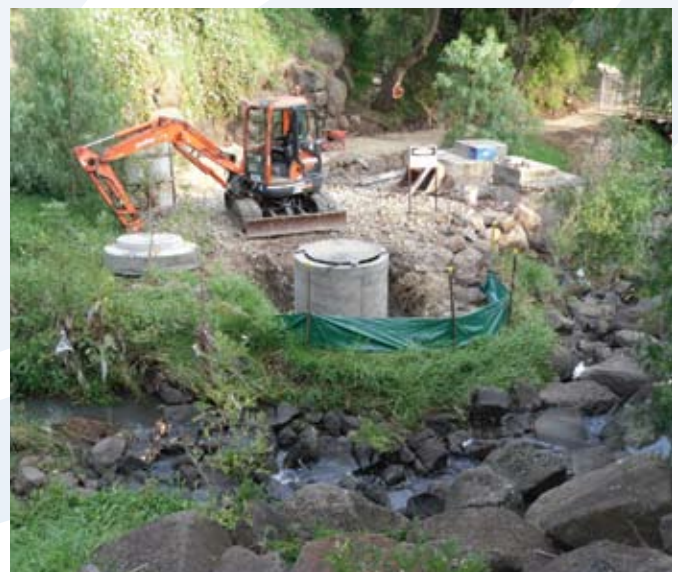
The man hole is 8 meters deep, (Approximately 6 m below water level) with significant erosion due to H₂S gas, seen overleaf. The concrete here has completely eroded to expose subsoil.

After initial externally controlled high pressure cleaning, the extent of water ingress can be determined. This is abated by applying hydraulic quick setting cementitious plug material to those areas.

Once infiltration is under control the initial application of Calcium Aluminate Cement is applied through Shield Technology's remote controlled pneumatic spinning head.

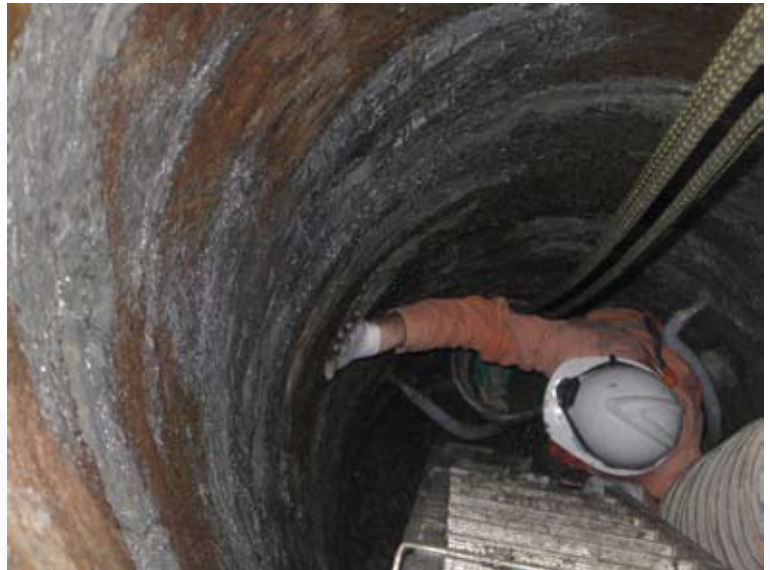
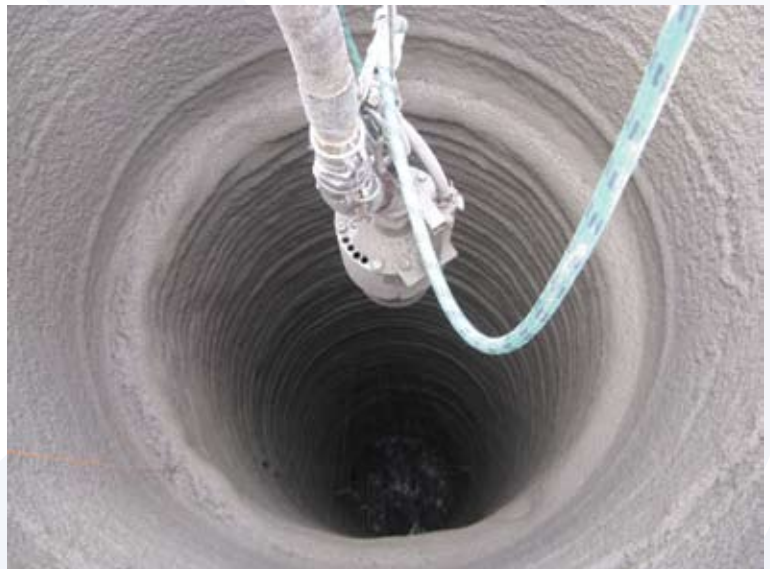
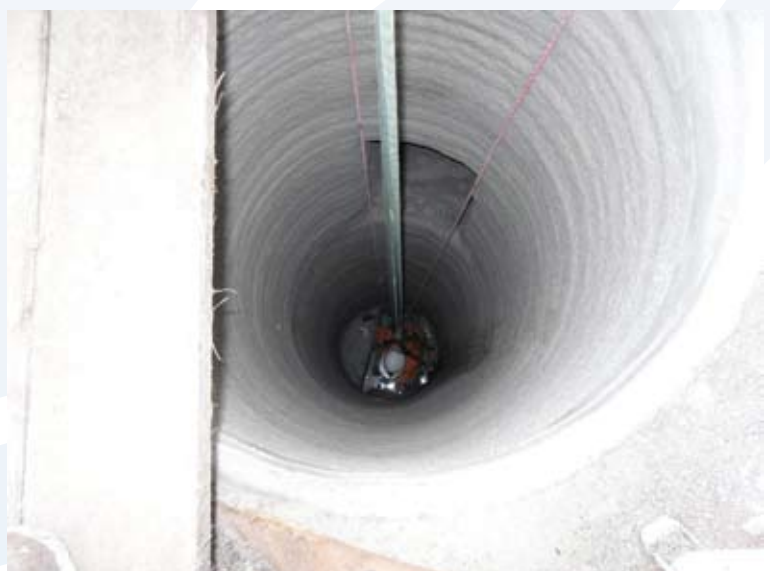
The spinning head provides an easy, non-man entry means of applying the Calcium Aluminate Cement. The material being slung onto the walls provides good consistent compaction of the CAC.

Completed application provides an H₂S corrosive resistant and structurally rehabilitated manhole.
