# Melbourne Manhole Restoration: Calcium Aluminate

## Restoration of Manhole with Calcium Aluminate

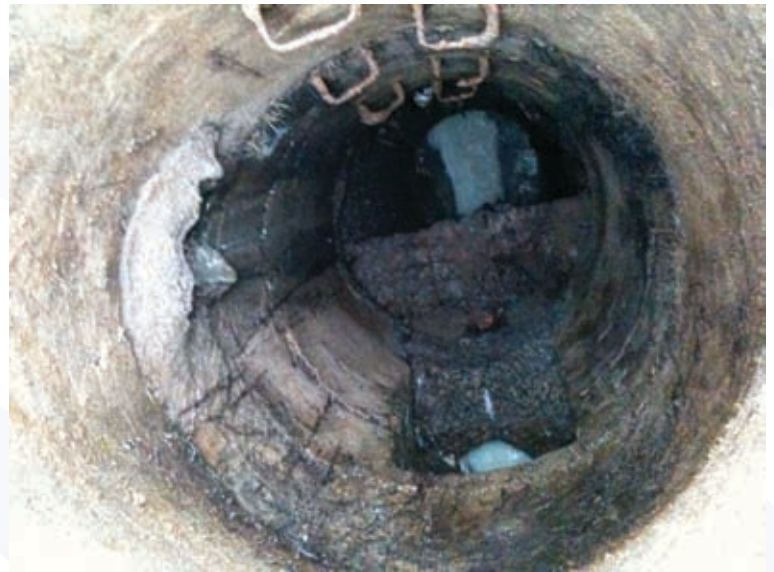
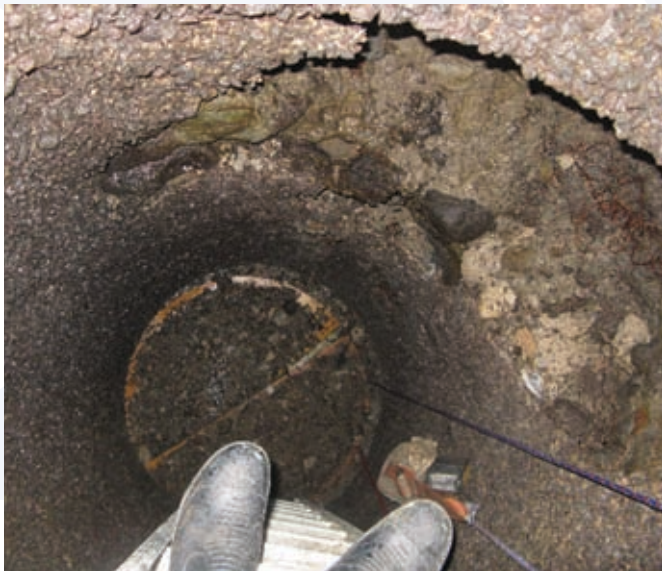
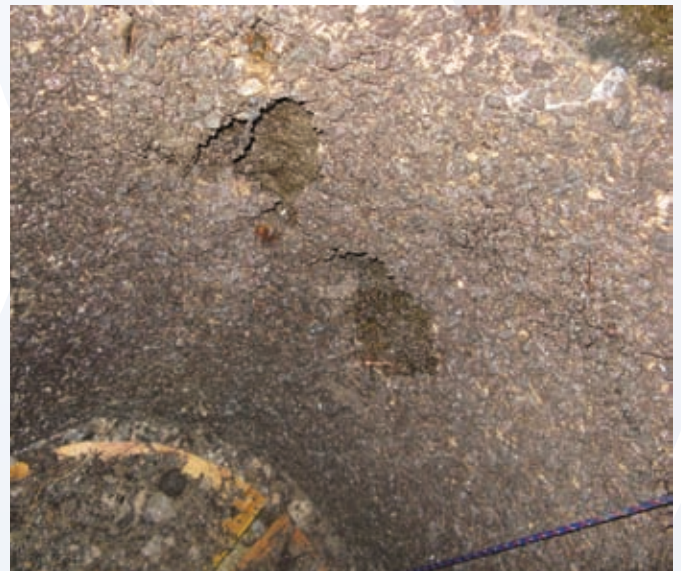
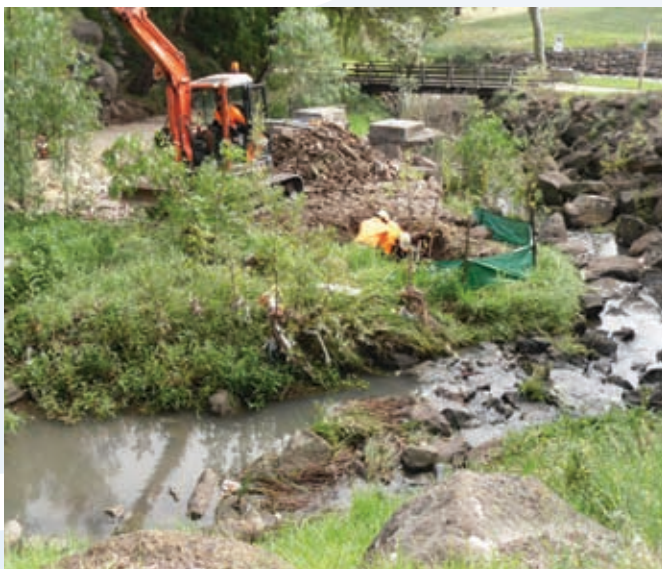
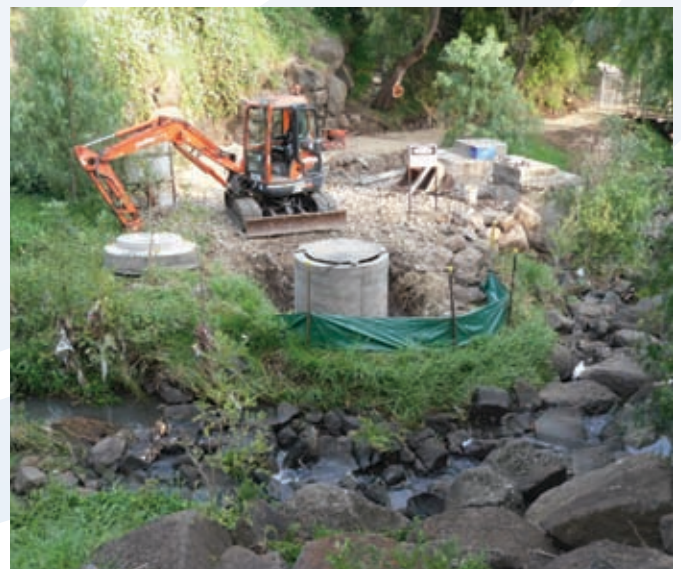
The man hole is 8 meters deep, (Approximately 6 m below water level) with significant erosion due to H<sub>2</sub>S gas, seen overleaf. The concrete here has completely eroded to expose subsoil.

After initial externally controlled high pressure cleaning, the extent of water ingress can be determined. This is abated by applying hydraulic quick setting cementitious plug material to those areas.

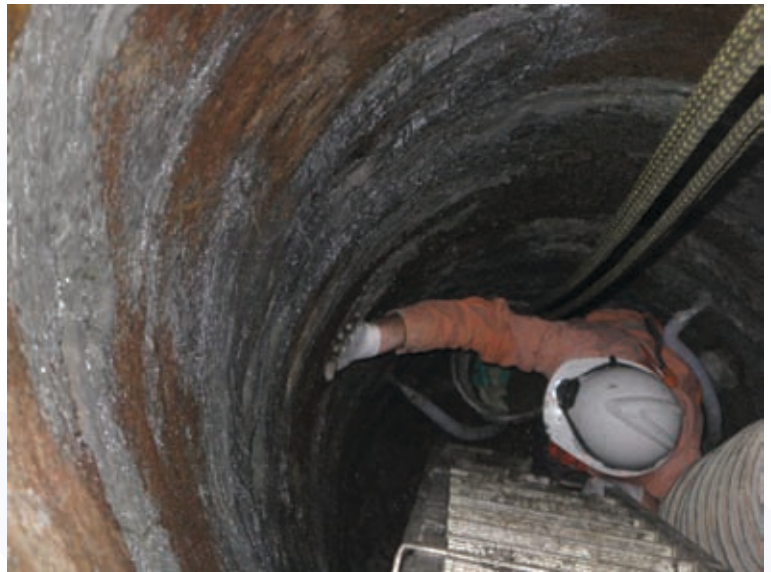
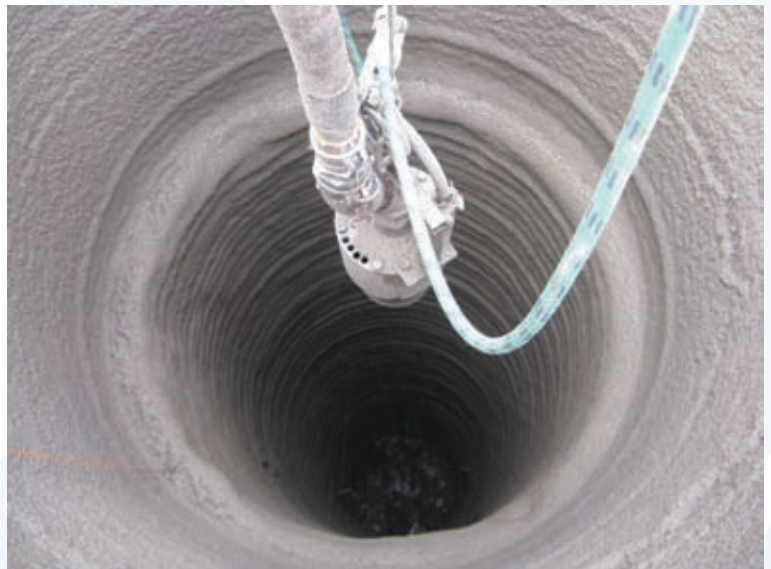
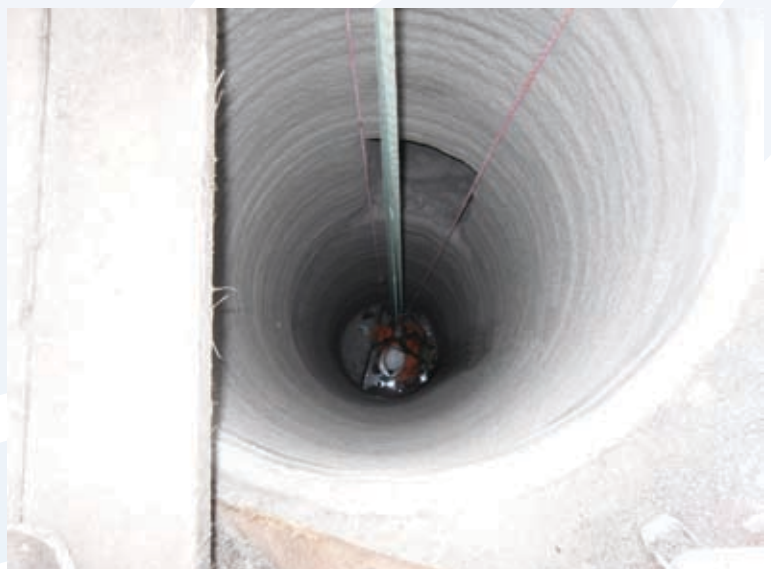
Once infiltration is under control the initial application of Calcium Aluminate Cement is applied through Shield Technology's remote controlled pneumatic spinning head.

The spinning head provides an easy, non-man entry means of applying the Calcium Aluminate Cement. The material being slung onto the walls provides good consistent compaction of the CAC.

Completed application provides an H<sub>2</sub>S corrosive resistant and structurally rehabilitated manhole.
